# Intel<sup>®</sup> 82801DBM I/O Controller Hub 4 Mobile (ICH4-M)

## Specification Update

*October 2005*

Document Number: 252663-007

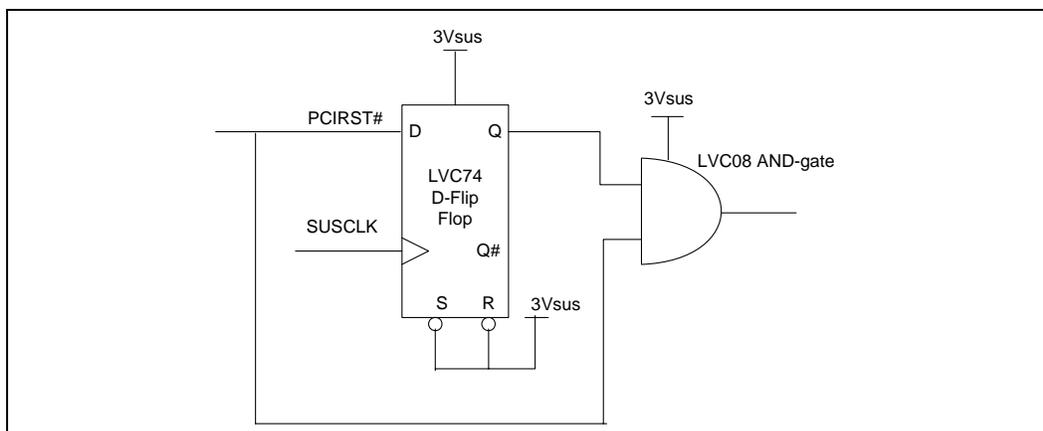
**Problem:** The ICH4-M specified 1–3 RTC timing of SUS\_STAT# inactive to PCIRST# inactive violates the LPC Rev 1.0 specification of “at least 60  $\mu$ s.”

**Implication:** Some LPC devices (based on LPC Rev 1.0) may not properly reset resulting in failure of the system to boot or resume from a sleep state.

1. Delay PCIRST# by 1 SUSCLK using a D-flop and an AND gate to the LPC devices.
