# 21150 PCI-to-PCI Bridge

Specification Update

*October 2001*

Order Number: [278258-009](#)

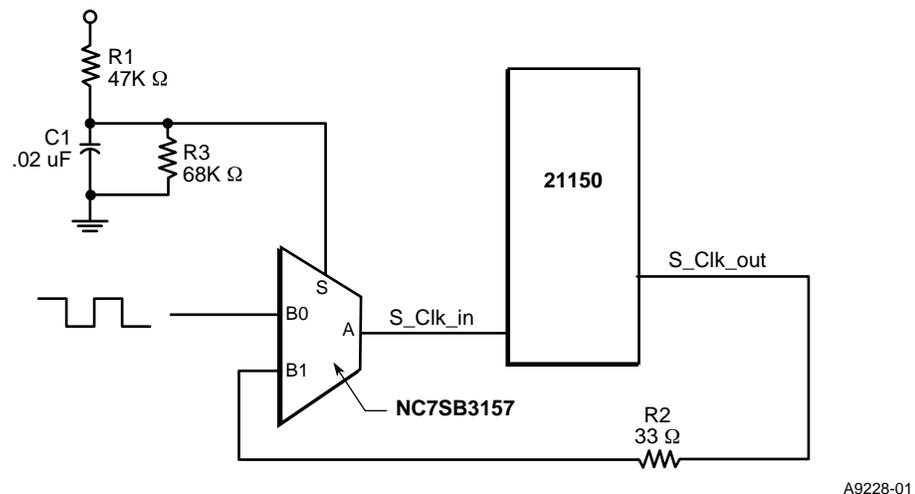
**Figure 1. S\_Clock Multiplexer Workaround Circuit for Errata 6.**

**Problem:** This problem has been found on the 21150AC and 21150BC. Under repeated and frequent power cycling, the secondary clock circuits may not power up in the proper state, resulting in the device not coming out of reset after power up.

**Implication:** In a system with a 21150AC or 21150BC that has one of its s\_clk\_o<9:0> outputs fed back to provide the s\_clk, it is possible that the s\_clk\_o<9:0> output clocks will be driven and remain low, keeping s\_rst\_l asserted, during system power up.

This happens occasionally when a latch whose output disables the serial shift registers on the Secondary clock control powers up in a high state and the shift register bit corresponding to the s\_clk\_o<9:0> output that is fed back also powers up in the high state.

1. [Figure 1](#) illustrates the first recommendation - a circuit where an on-board pulse source is gated via the B0 input of the multiplexer to the S\_Clock\_in pin of the 21150.

At time 0, the S input of the multiplexer is low, allowing pulses from the on-board pulse source, connected to the B0 input, to be provided to the 21150 S\_Clk input pin. When the time determined by the R/C network is satisfied, the S input pin will be in a logic High state. The Multiplexer will then shut off the input pulse from S0 and will direct the S\_Clock\_out pulses via the B1 multiplexer input, into S\_Clock\_in.

The values used for the R/C network should be selected to allow a minimum of 2 pulses to be delivered to the 21150 after V<sub>dd</sub> has reached 3.0V at a frequency not to exceed the appropriate PCI component. i.e. 30 ns for a 33Mhz bridge. These values should be chosen based on the rise time of the power supply and the frequency of the on board pulse source. The values given for R1, R3, and C1 are for example purposes only.

**Note:** The NC7SB3157 2:1 Multiplexer / Demultiplexer Bus Switch used in this example has a maximum propagation delay of 800ps that should be taken into consideration when matching trace lengths of the clock lines to avoid introducing excessive skew in the clocks. All S\_Clock etch lengths must be matched to within 2ns @ 33Mhz or 1ns @ 66Mhz. The addition of this circuit requires that the etch length for the S\_clock\_in signal be reduced to compensate for the 800ps delay.

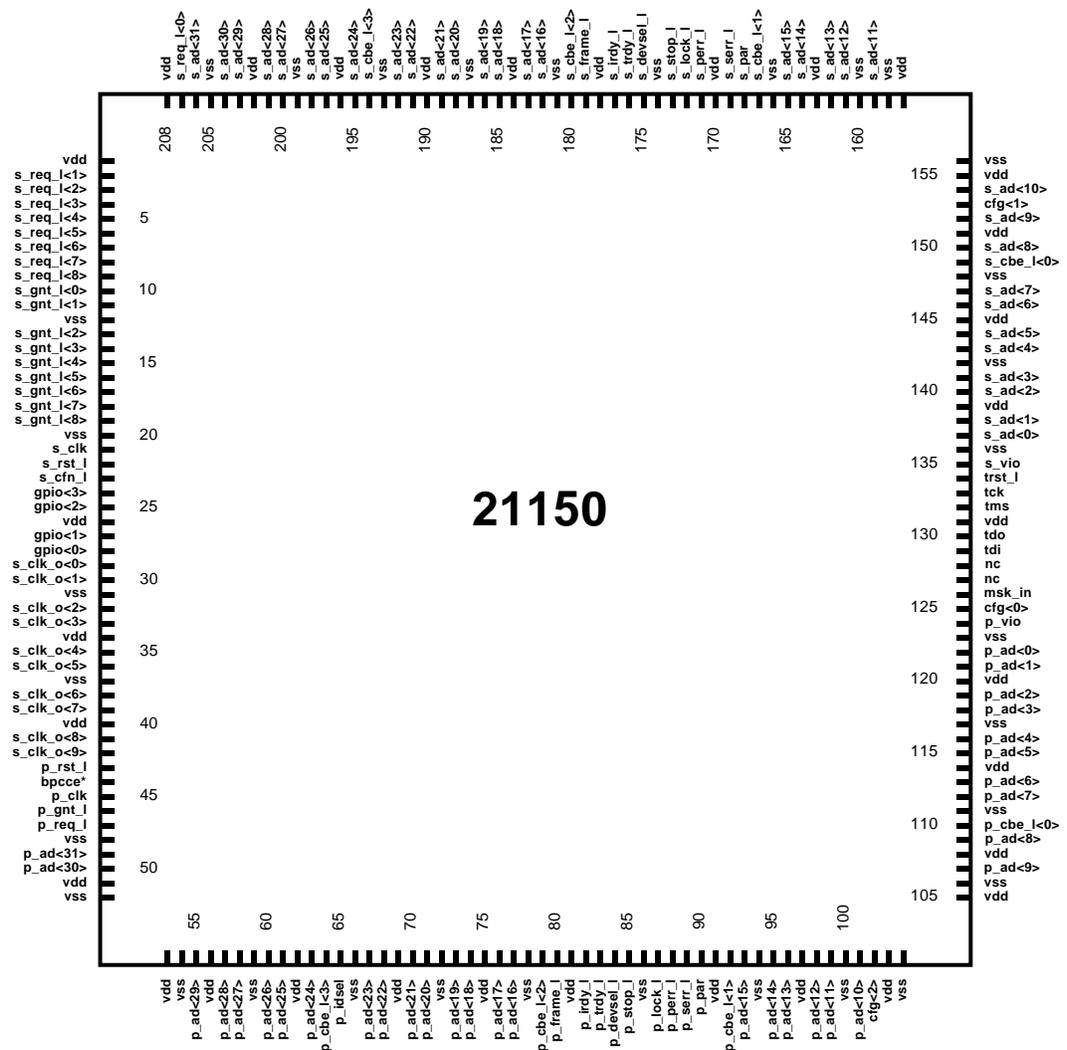
## 1. Section 3.0, Figure 5, 21150 Pin Assignment

Pin 44 should be designated bpcce\*. The following note should be added to the drawing: \*For 21150AB and later revisions only. This is a vss pin for the 21150AA.

\* For 21150-AB and later revisions only.  
This is a vss pin for the 21150-AA.

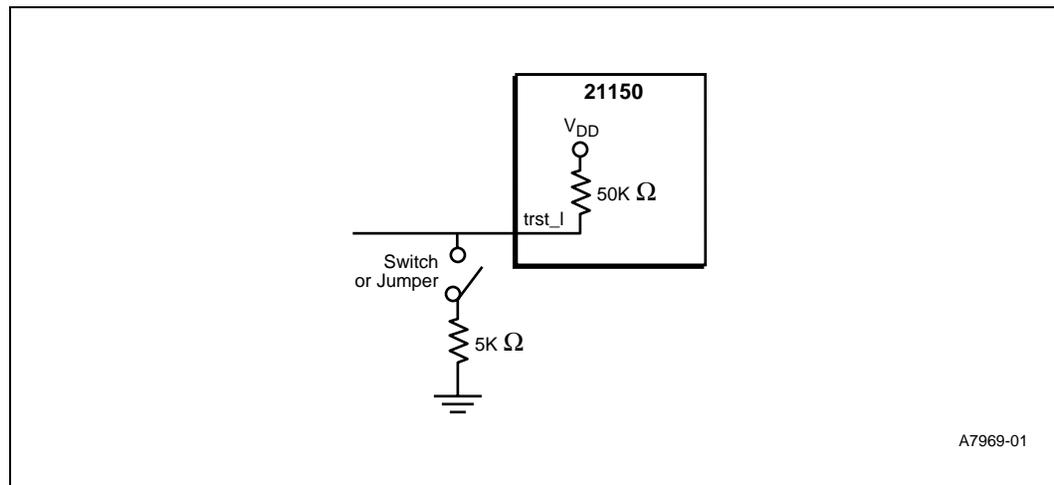
**Figure 2. Removal of pull-down resistor for JTAG testing**

A 5 K  $\Omega$  pull-down resistor is required on trst\_l for normal PCI-to-PCI bridge operation. However, some JTAG test results may be inconclusive if the 5 K  $\Omega$  resistor remains in the circuit. To obtain accurate JTAG results, Intel recommends one of the following solutions:

- Verify that the JTAG test equipment, after driving trst\_l low to reset the TAP controller, constantly drives trst\_l high during JTAG tests. If this signal is not constantly driven high, the 5 K  $\Omega$  resistor will pull the signal to a low state.
- Remove the 5 K  $\Omega$  resistor during JTAG tests. This resistor must be installed during normal PCI-to-PCI bridge operation.
- Design external circuits with a switch or jumper to isolate the 5 K  $\Omega$  resistor during JTAG tests (see [Figure 2](#)). This switch must enable the resistor during normal PCI-to-PCI bridge operation.
