# 21150 PCI-to-PCI Bridge

Specification Update

*October 2001*

Order Number: [278258-009](#)

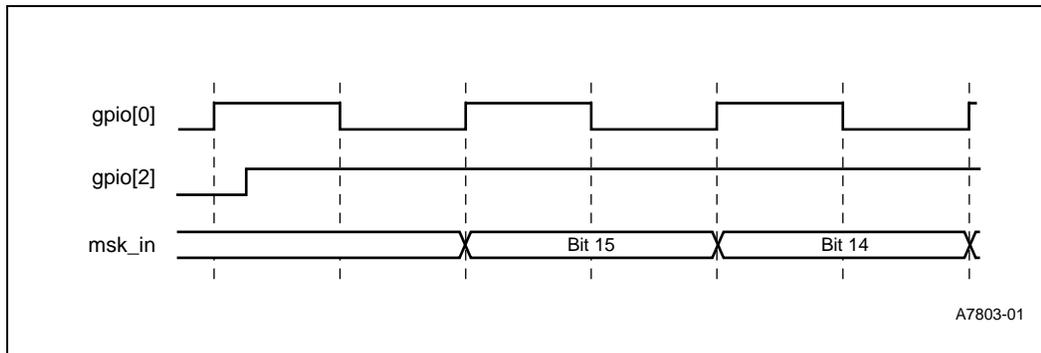
**Figure 20. Clock Mask and Load Shift Timing**

2. **Section 10.2, Secondary Clock Control, Figure 20**

This figure now appears as follows:

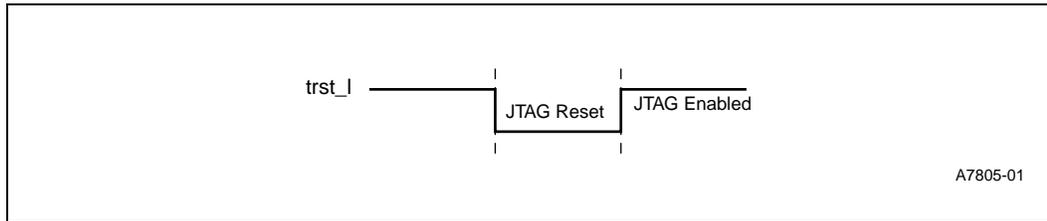
**Figure 4. Signal trst\_l States**

The test access port controller and the instruction register output latches are initialized and JTAG is disabled while the trst\_l input is asserted low (see [Figure 4](#)). While signal trst\_l is low, the test access port controller enters the test-logic reset state. This results in the instruction register being reset which holds the bypass register instruction. During test-logic reset state, all JTAG test logic is disabled, and the device performs normal functions. The test access port controller leaves this state only after trst\_l (low) goes high and an appropriate JTAG test operation sequence is sent on the tms and tck pins.

During normal 21150 operation the JTAG logic must be disabled by pulling trst\_l low using a 5K resistor.

A 5 K  $\Omega$  pull-down resistor is required on trst\_l for normal PCI-to-PCI bridge operation. However, some JTAG test results may be inconclusive if the 5 K  $\Omega$  resistor remains in the circuit. To obtain accurate JTAG results, Intel recommends one of the following solutions:

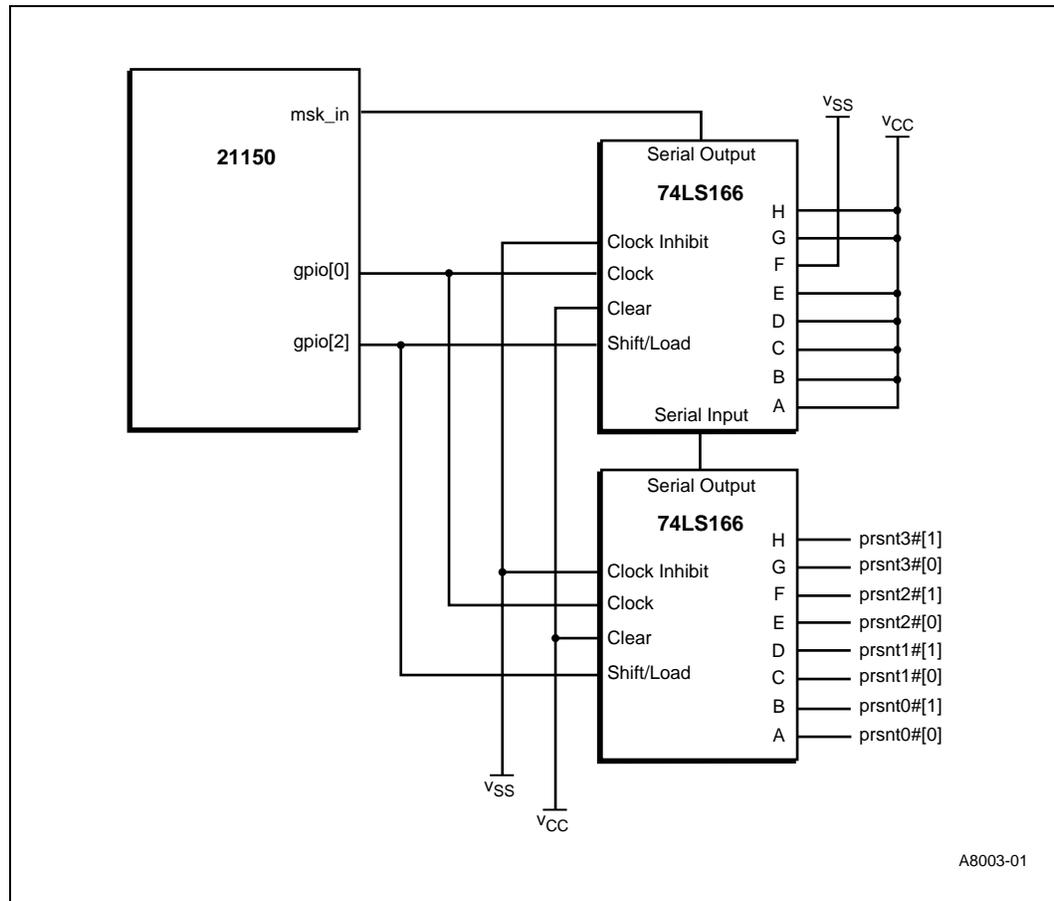
**Figure 19. Example of gpio Clock Mask Implementation on the System Board**

**12. Section 10.2, Secondary Clock Control, Figure 19**

This figure now appears as follows:
