Intel[®] I/O Controller Hub 6 (ICH6) Family

Specification Update

November 2007

Document Number: 301474-025

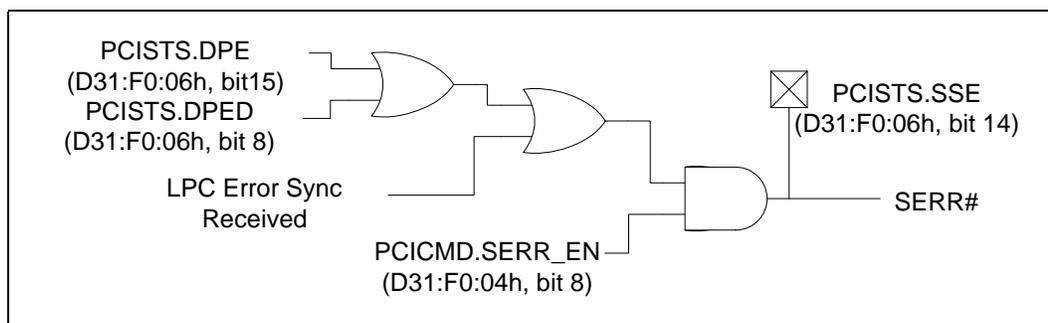
Figure 5-4. LPC Bridge SERR# Generation

Several internal and external sources of the LPC Bridge can cause SERR#, as described below.

The first class of errors is parity errors related to the backbone. The LPC Bridge captures generic data parity errors (errors it finds on the backbone) as well as errors returned on the backbone cycles where the bridge was the master and parity error response is enabled. If either of these two conditions is met, and with SERR# enable (PCICMD.SERR_EN) set, SERR# will be captured.

Additionally, if the LPC Bridge receives an error SYNC on LPC bus, an SERR# will also be generated.
