# 2nd Generation Intel<sup>®</sup> Core<sup>™</sup> Processor Family Desktop and Intel<sup>®</sup> Pentium<sup>®</sup> Processor Family Desktop

Specification Update

Reference Number: 324643-015

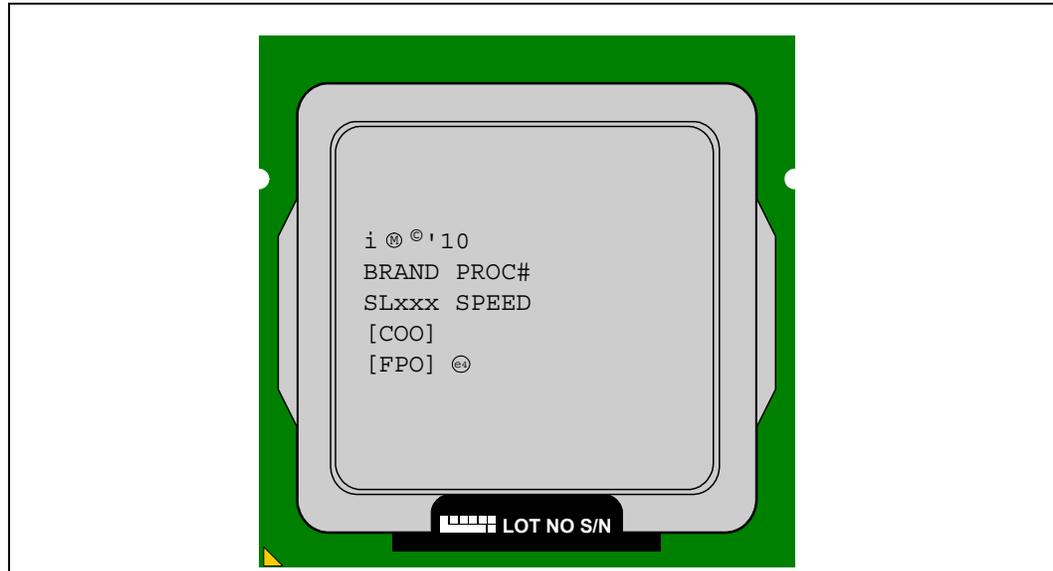
**Figure 1. Processor Production Top-side Markings (Example)**

The processor stepping can be identified by the following component markings:
