2nd Generation Intel[®] Core[™] Processor Family Desktop, Intel[®] Pentium[®] Processor Family Desktop, and Intel[®] Celeron[®] Processor Family Desktop

Specification Update

October 2014

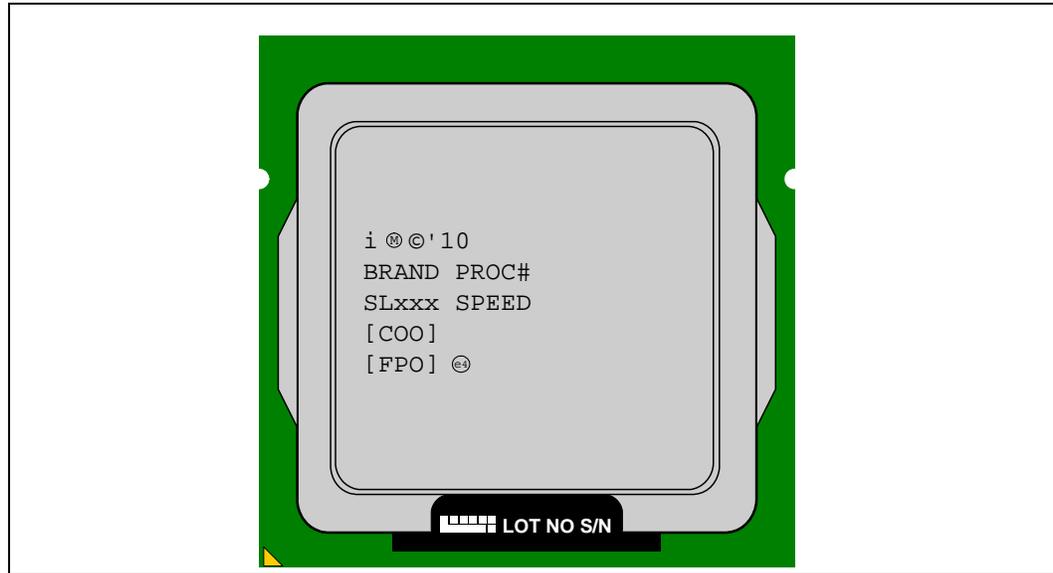
Figure 1. Processor Production Top-side Markings (Example)

The processor stepping can be identified by the following component markings.
