This guide summarizes the experience of modifying LuckyStar LS-486e Rev:D motherboards. All upgrades described below are proven to work.

Changes overview

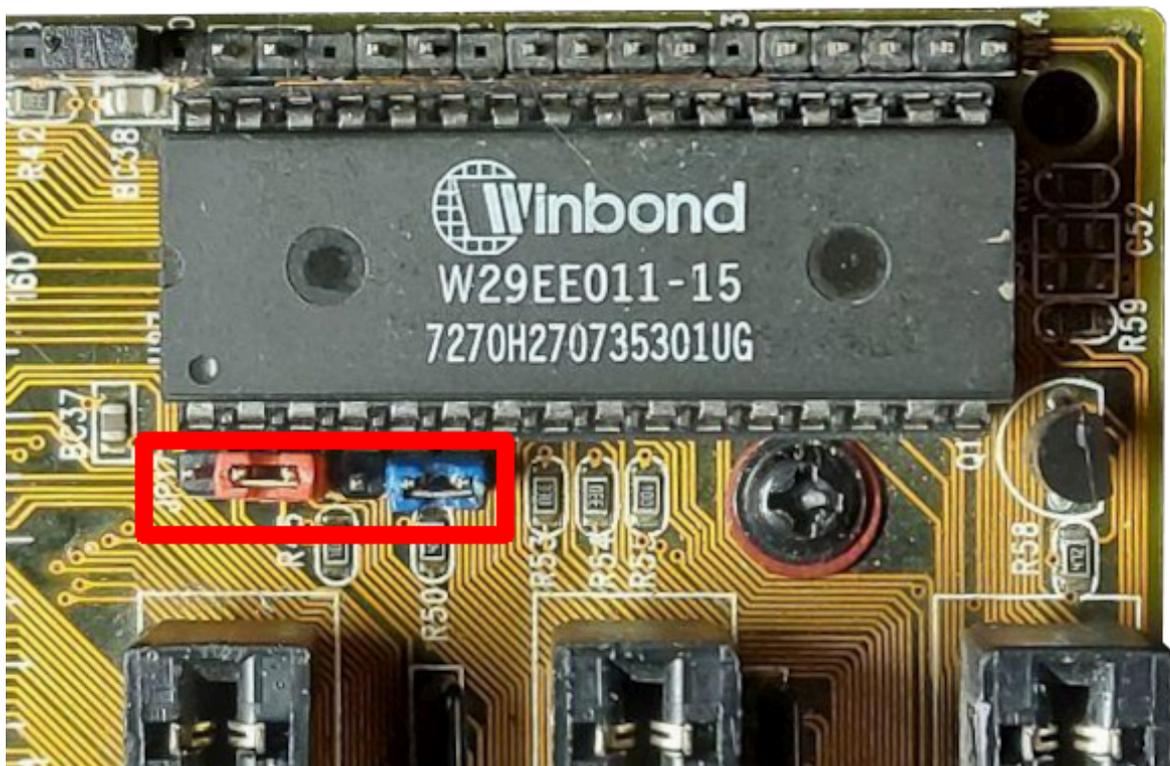
Fig. 2

1. De-solder jumper wires from JP17 pins 2-3 and 4-5. Save them for later use.
2. Solder 5-pin header into JP17 footprint (see Fig. 2)
3. Set jumper caps between pins 2-3 and 5-6.

1-2	+12V programming
2-3	+5V programming *
4-5	Write disabled *
5-6	Write enabled

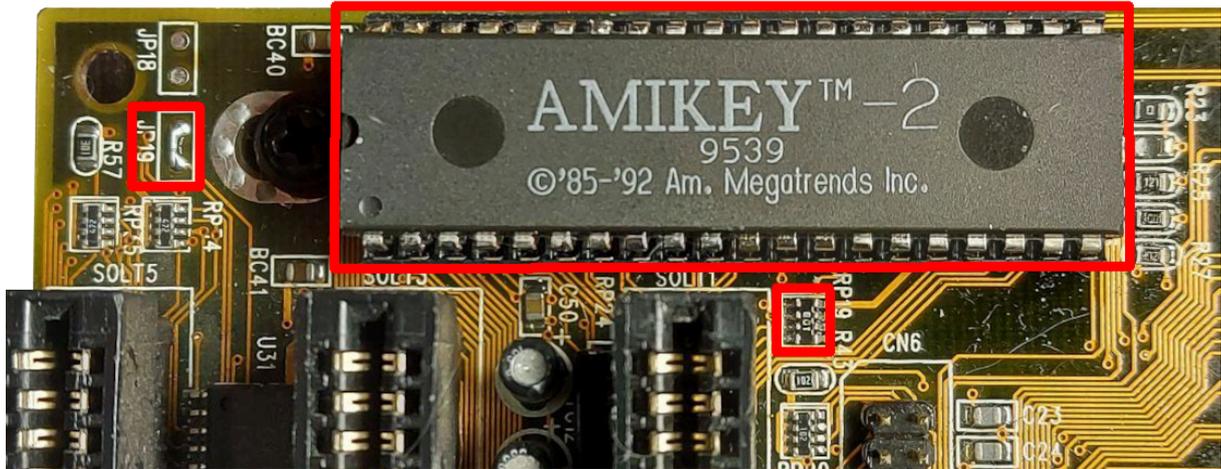
Fig. 3.1

1. De-solder existing keyboard controller U28 (VIA VT82C41)
2. Solder resistor array RP19 (4 × 10 kOhm)
3. Solder JP19 close with jumper wire as shown on Fig 3.1

6. Solder new keyboard controller U30 (HT6542B) as shown on Fig 3.1
7. Solder capacitors C5 and C7 (47 pF) as shown on Fig 3.4
8. Solder inductors L4 and L5 (470 μ H) as shown on Fig 3.4

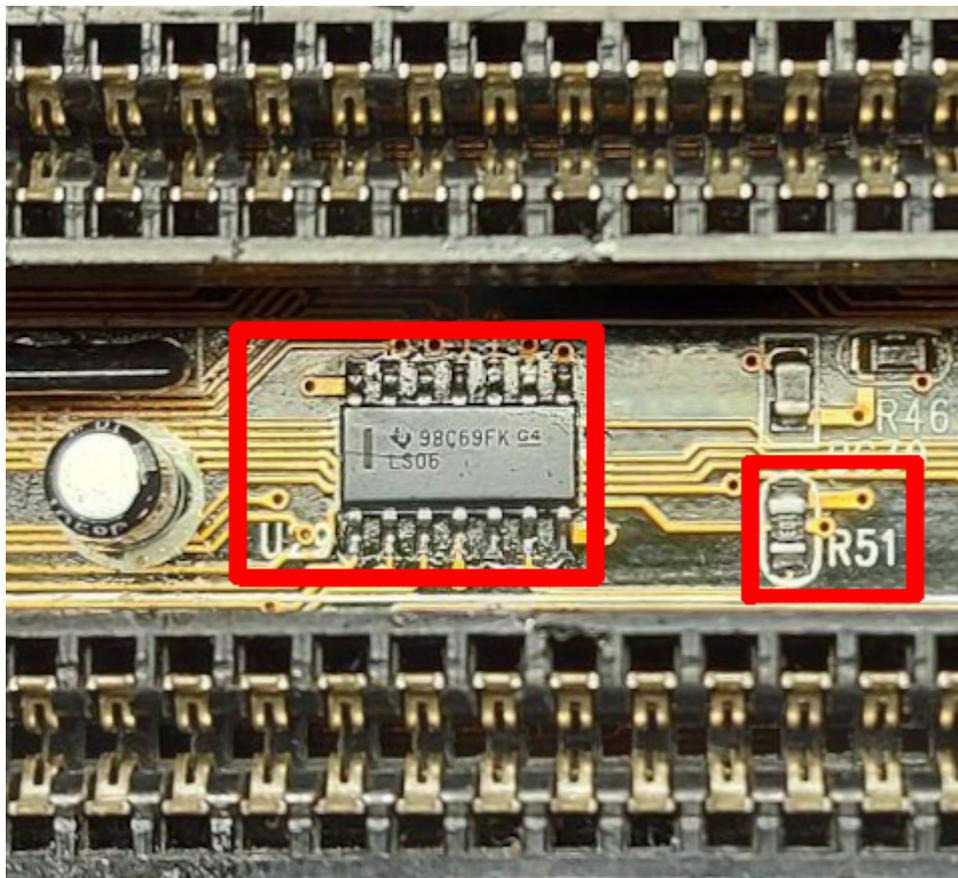
Fig. 3.2

4. Solder resistor R51 (4.7 kOhm)
5. Solder inverter buffers U29 (SN74LS06D) as shown on Fig 3.2

Note Due to interference of outputs once you solder inverter buffers you won't be able to revert back to VT82C41 keyboard controller unless you remove the inverter buffer chip completely.

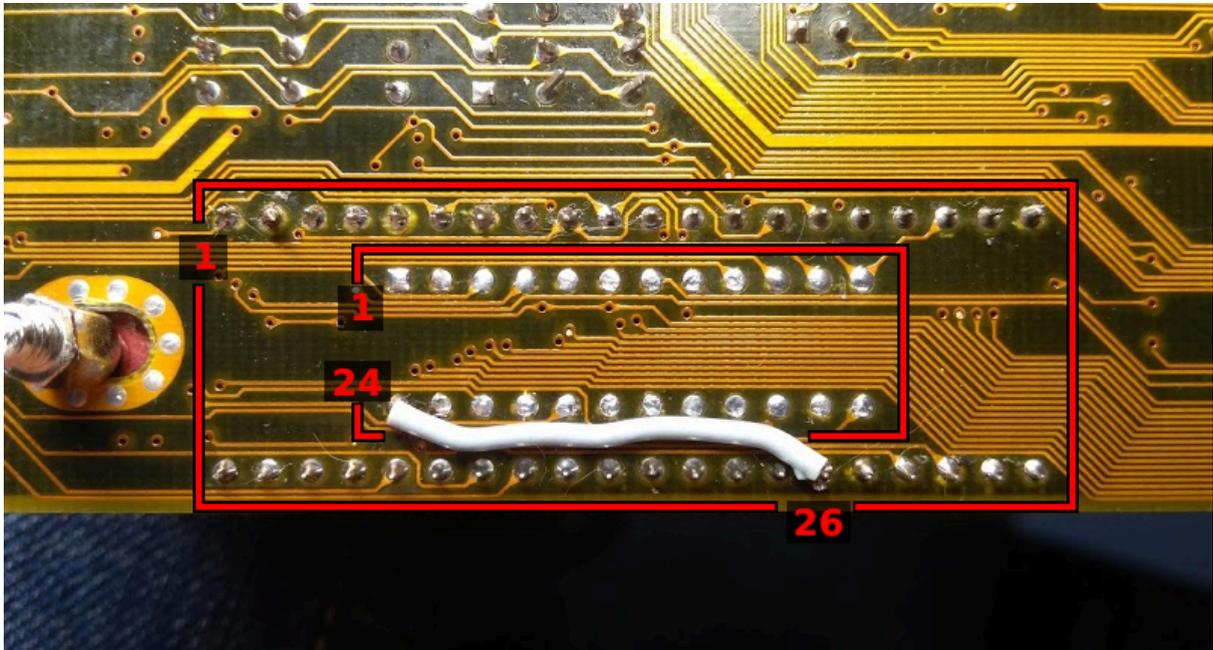
Fig. 3.3

- Solder jumper wire between pin 26 of U30 (HT6542B) and pin 24 of U28 (VIA VT82C41) on the bottom side as shown on Fig 3.3

Note Tying pin 26 of U30 to +5V is required for proper initialization of Holtek HT6542B. AMIKEY-2 was tested and worked fine without this option.

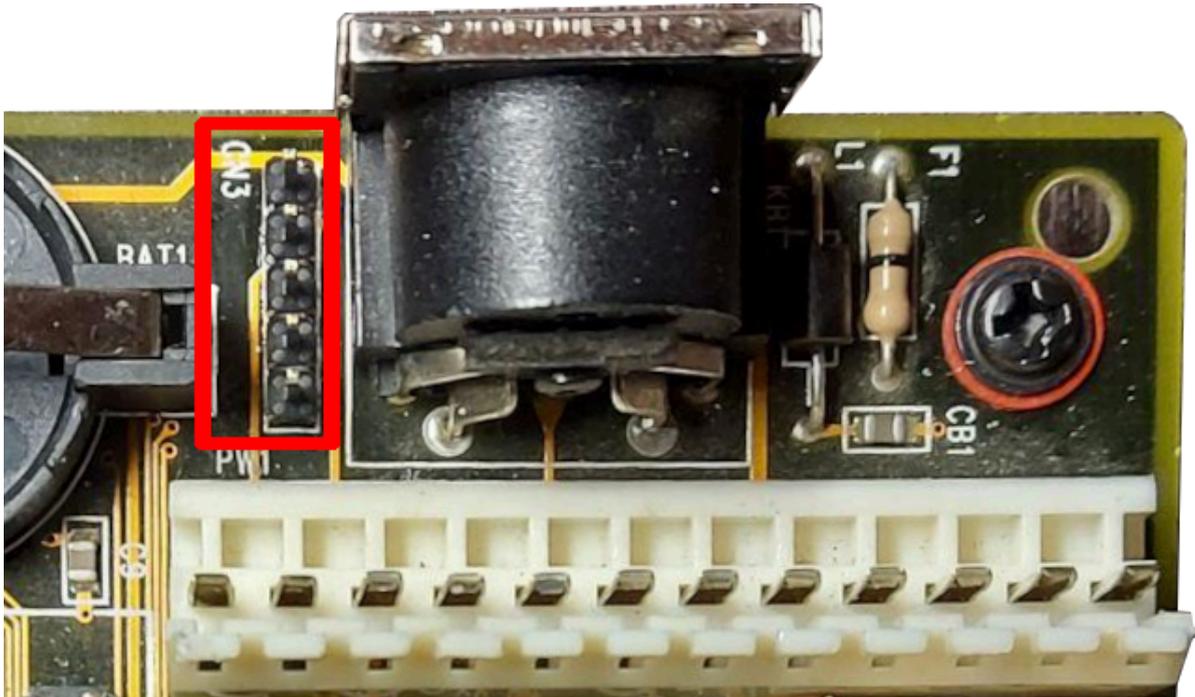
Fig. 3.5

10. Solder connector CN3 (5-pin header) as shown on Fig 3.5
